French Limited Wetlands Mitigation

Site Selection Report

**Crouch Environmental Services
12115 Wessex, Suite 100
Houston, Texas 77089
(713)579-2565**

April 25, 1994

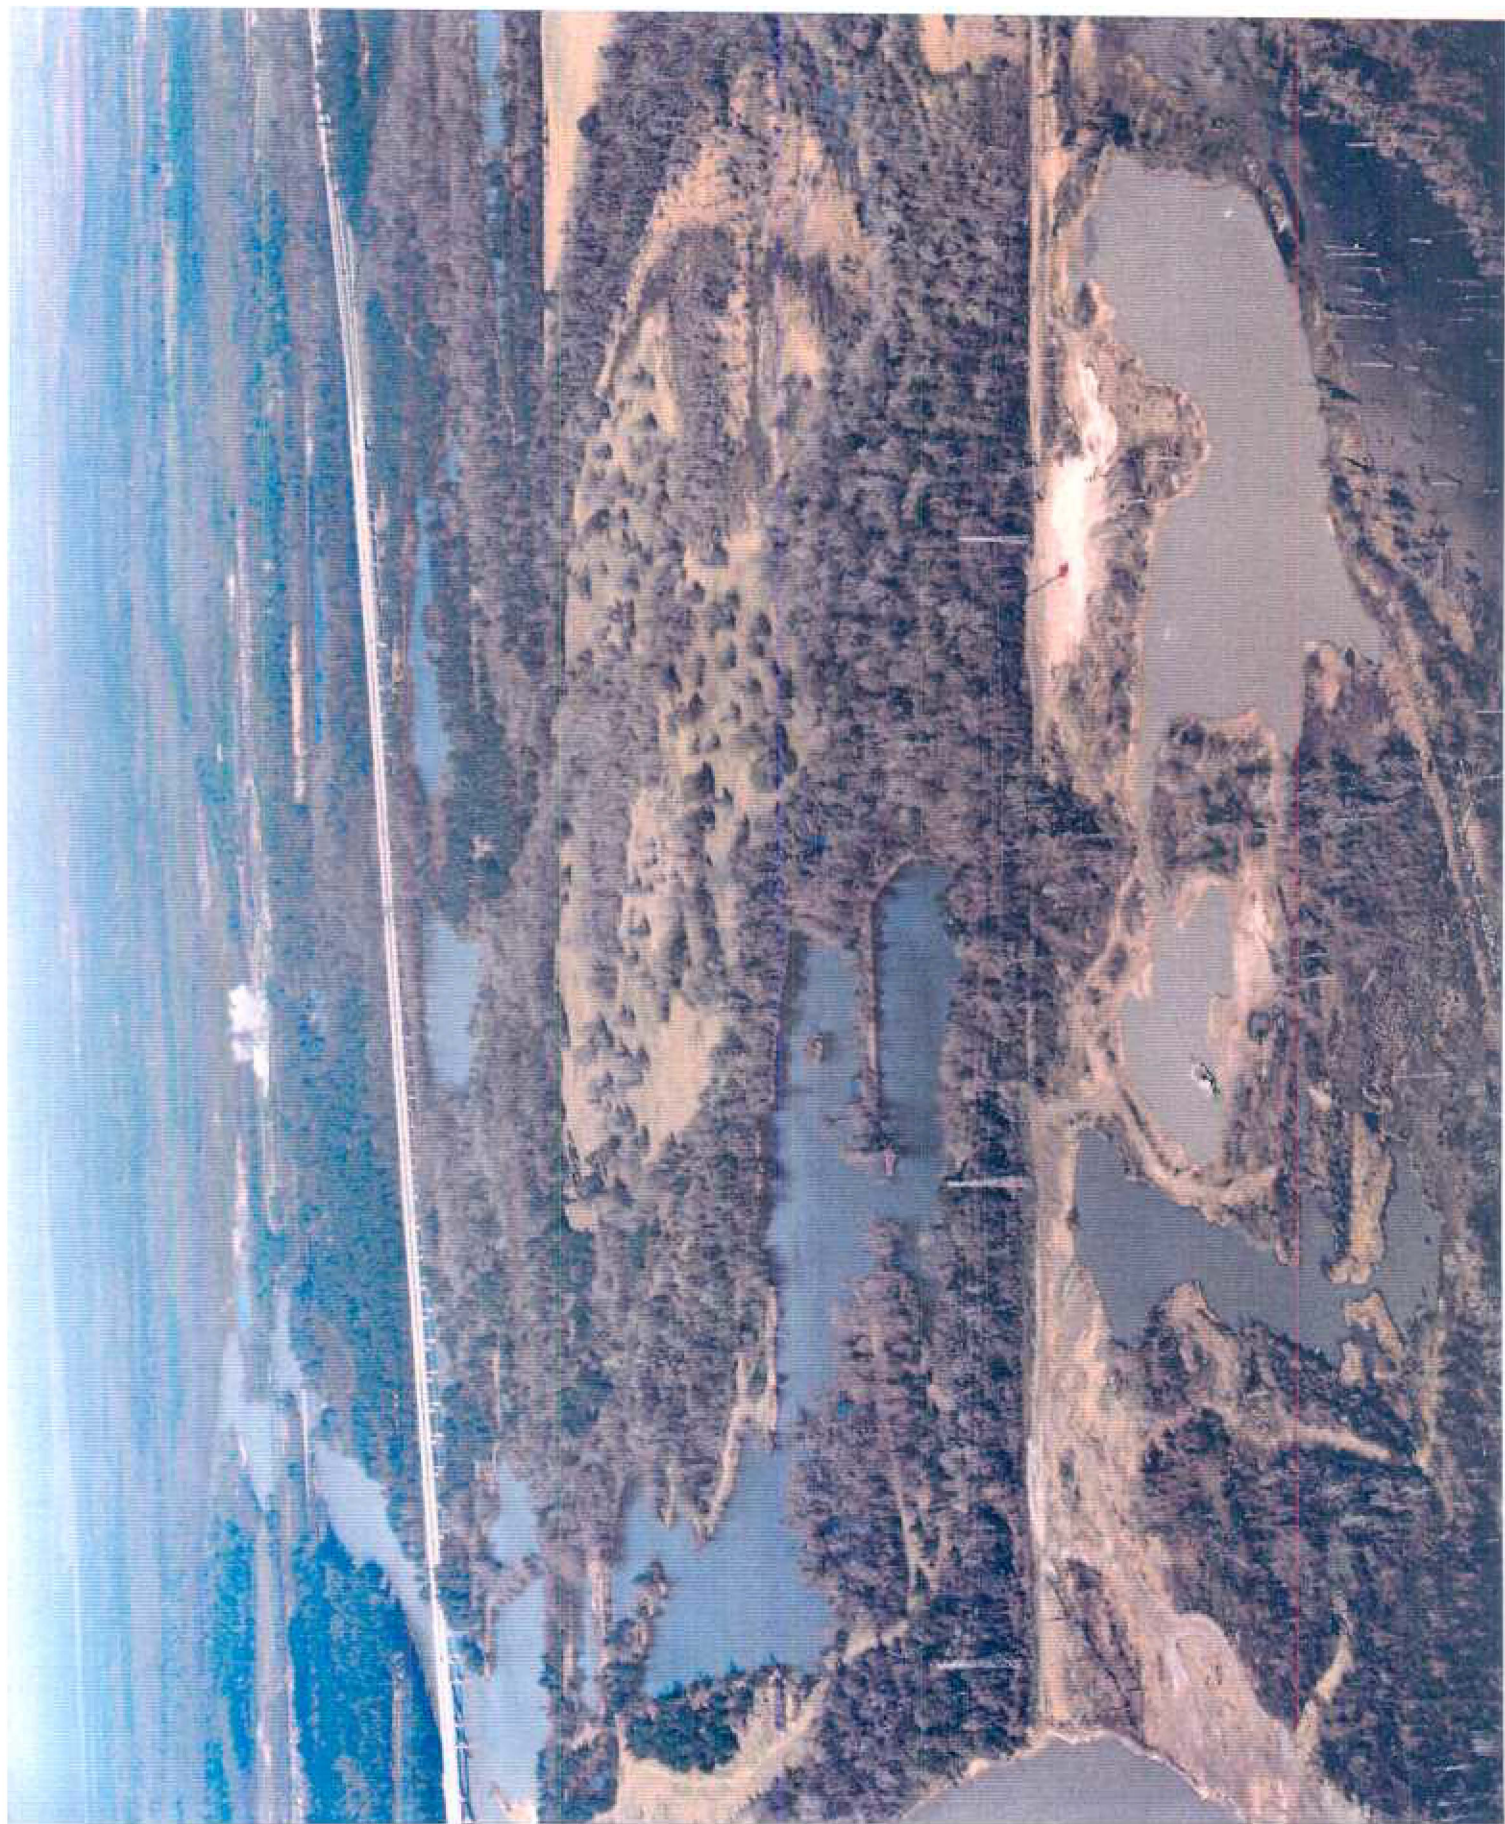
Barrett II Site

- Significant excavation required
- Road upgrade required
- Land ownership and cost unknown
- Moderate tree debris and soil disposal cost

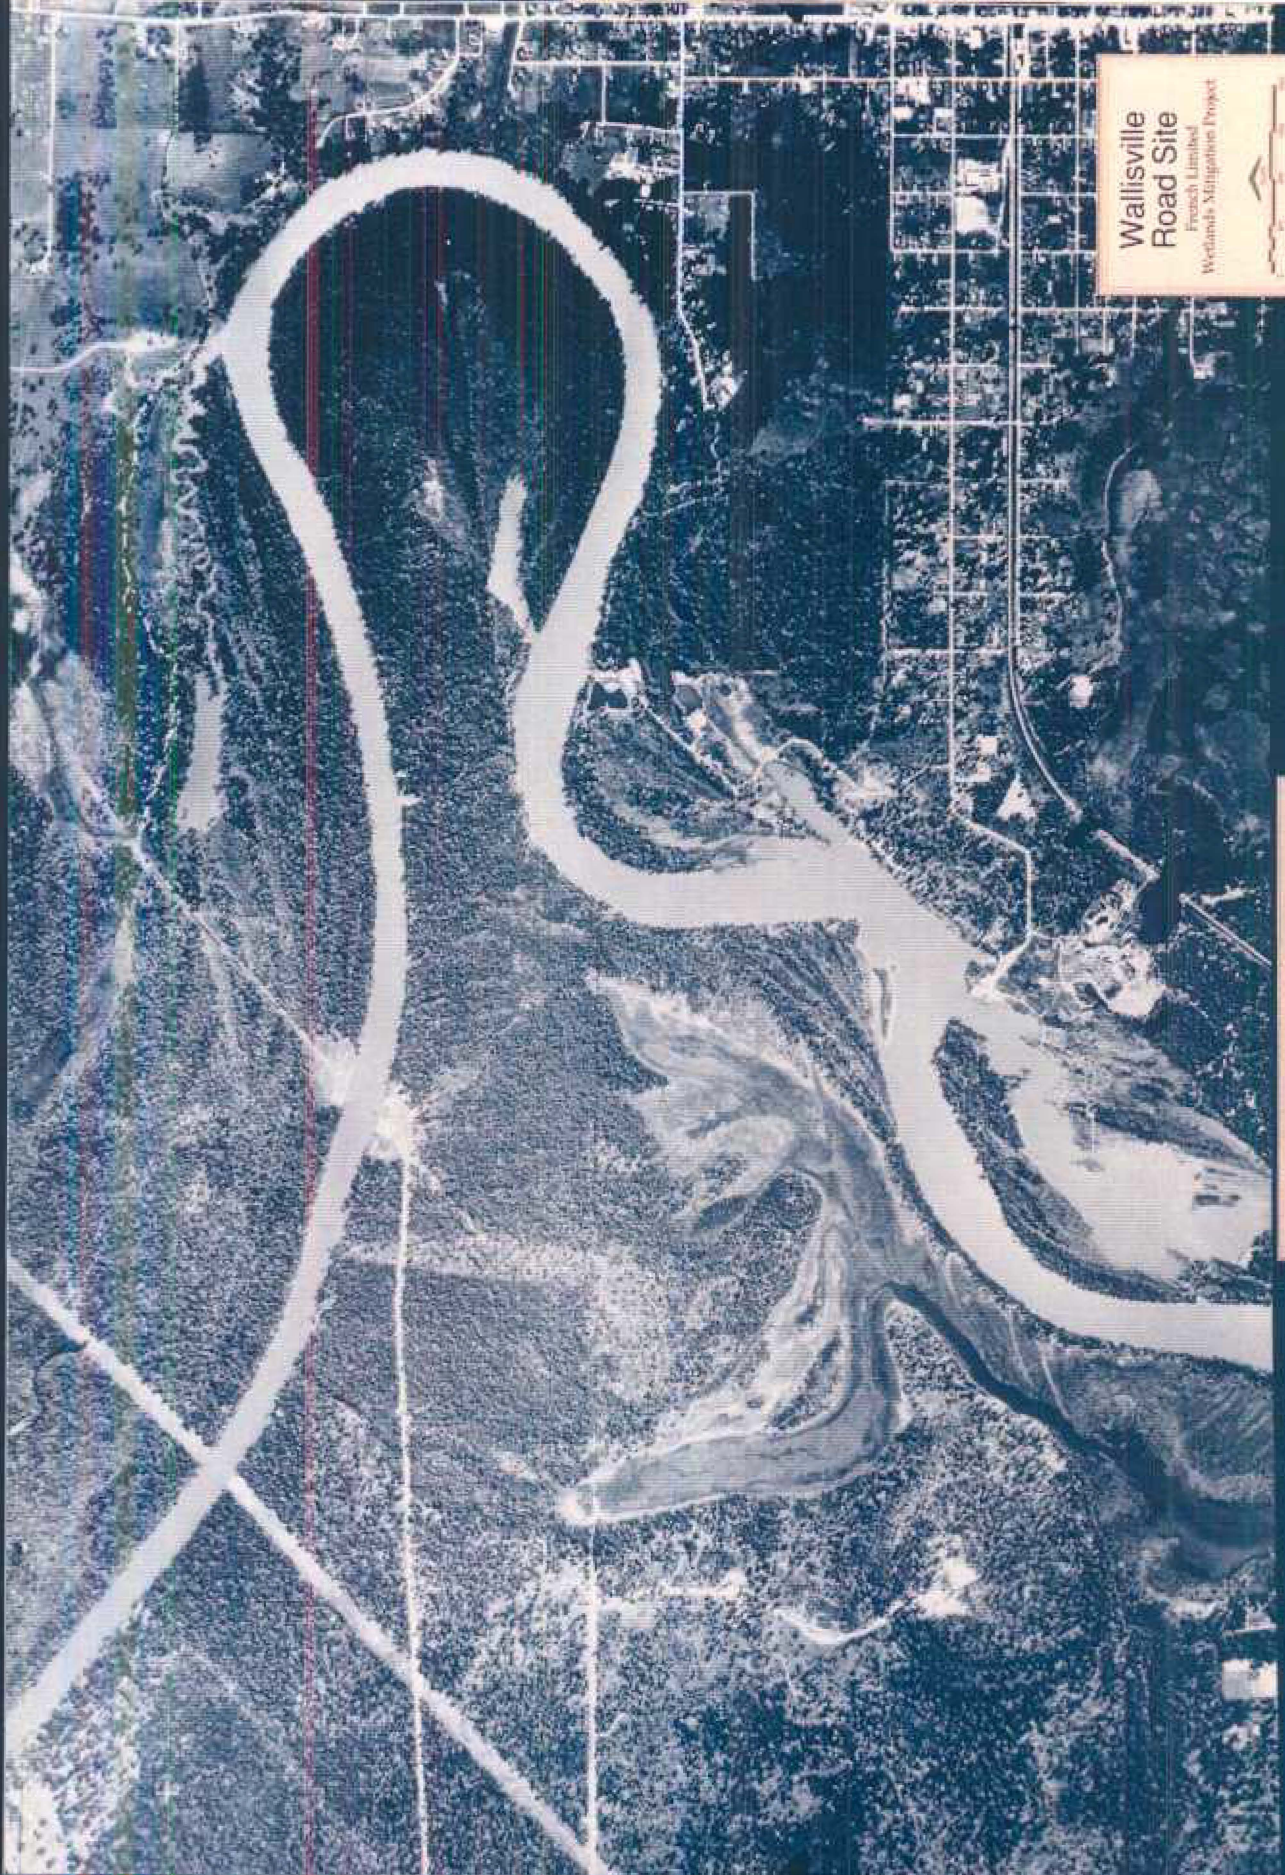
1953 Conditions : Context Map

Wallisville
Road Site
French Limited
Wetlands Mitigation Project

Aerial photos from 1953 show the Wallisville Road Site to be much larger than at present. It appears to have been a very large, probably high quality wetland site. If this site were selected, the response option would clearly be restoration of a destroyed or degraded wetland.

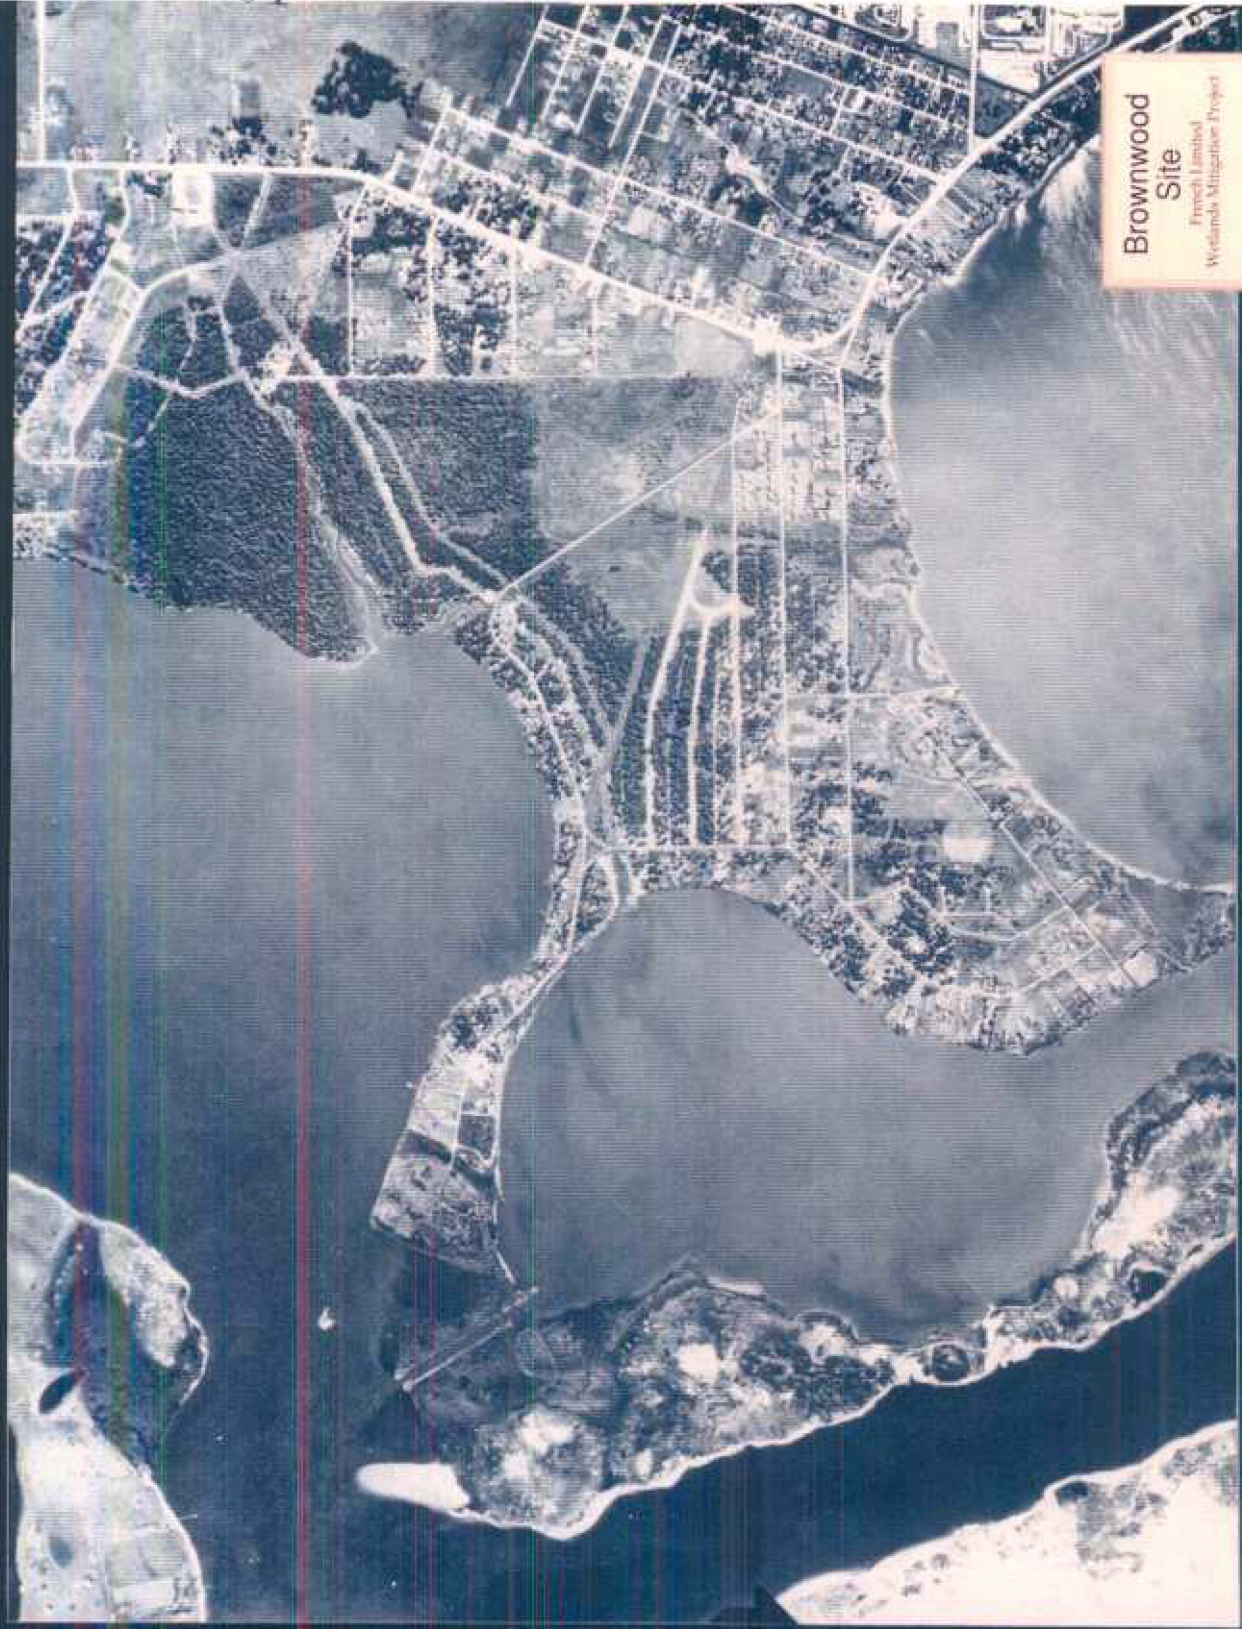
1953 Conditions : Context Map

Brownwood Site
French Limited
Wetlands Mitigation Project

The Brownwood Site is owned primarily by the City of Baytown, with some private ownership of a few pieces of property still remaining. Photos from 1953 demonstrate the significant land loss experienced in this area over the past 40 years. The area was at one time a substantial waterfront subdivision. It was abandoned in 1983 as a result of consistent flooding caused by subsidence due to groundwater withdrawal. A significant amount of the area now consists of standing water.

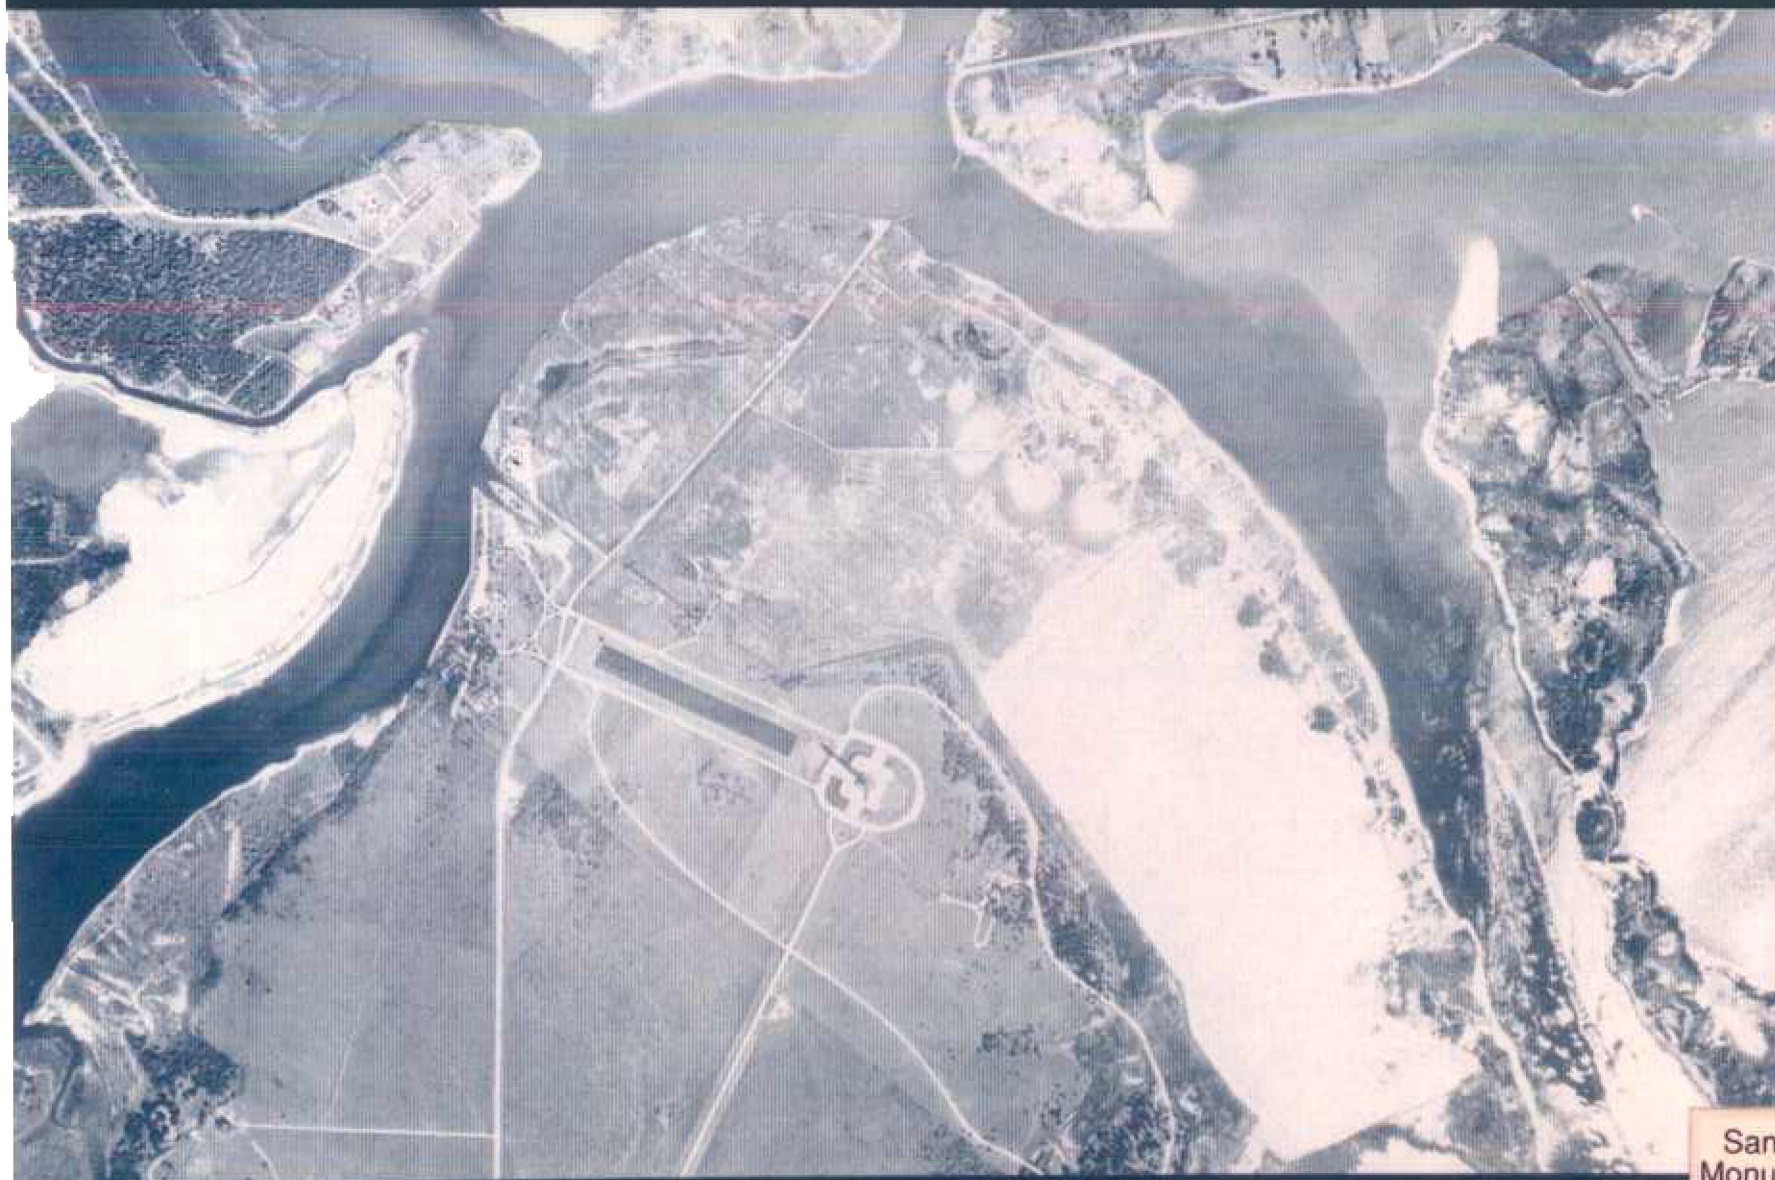
1953 Conditions : Context Map

**San Jacinto
Monument Site**
French Limited
Wetlands Mitigation Project

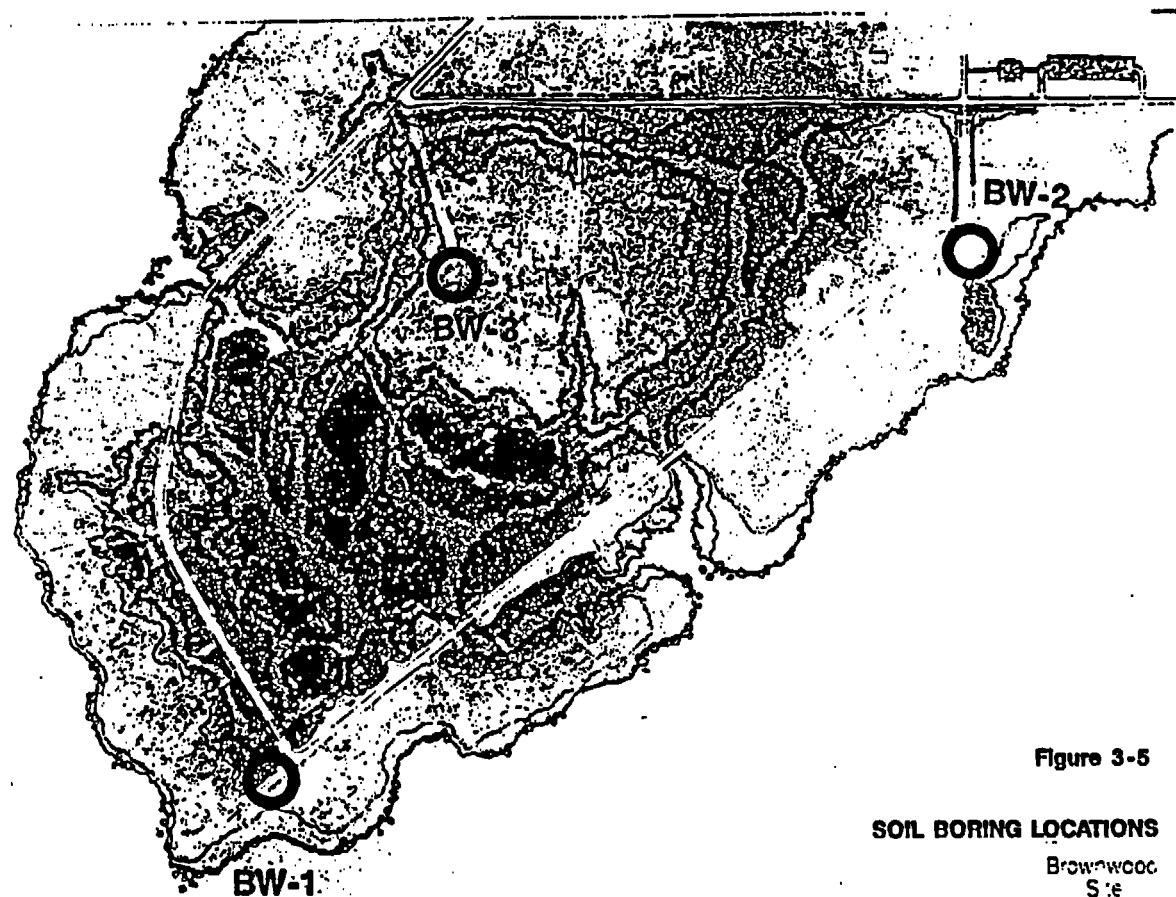
Figure 3-5

SOIL BORING LOCATIONS
Brownwood
Site

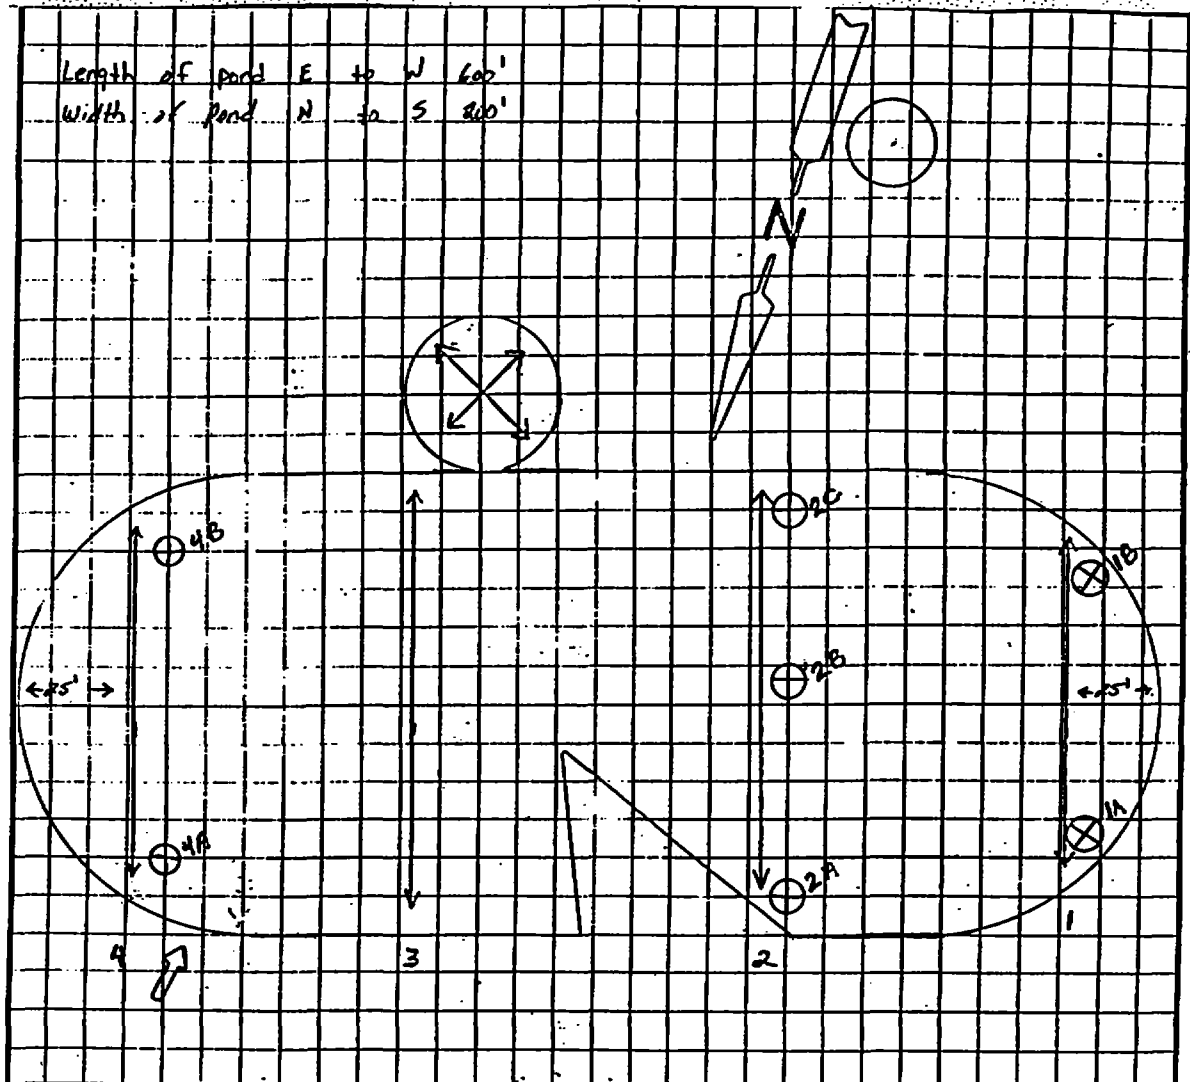
Figure 3-8

LOST POND TRANSECTS
AND SAMPLE LOCATIONS

Depths, Secchi disc and field parameters (temperature, specific conductance, pH and dissolved oxygen) were measured at seven locations in the Lost Pond, shown on Figure 3-8. These results are provided in Table 3-1. The water had very similar pH and turbidity to the main pond. DO was higher, despite being warmer on the day sampled. EC was very similar at approximately 13,000 $\mu\text{S}/\text{cm}$. This is equivalent to approximately 10,000 mg/L TDS, or about 30% of seawater salinity.
